RADIO SERVICE DEPARTMENT

SPECIAL SERVICE BULLETIN FOR EDISON RADIO SERVICE ENGINEERS

SUBJECT: "Elimination or the reduction of hum level in JR and JC chassis."

SUBJECT: "Ventilation of Power Packs in C-1 Models to prevent over-heating of filter condensers and loss of wax."

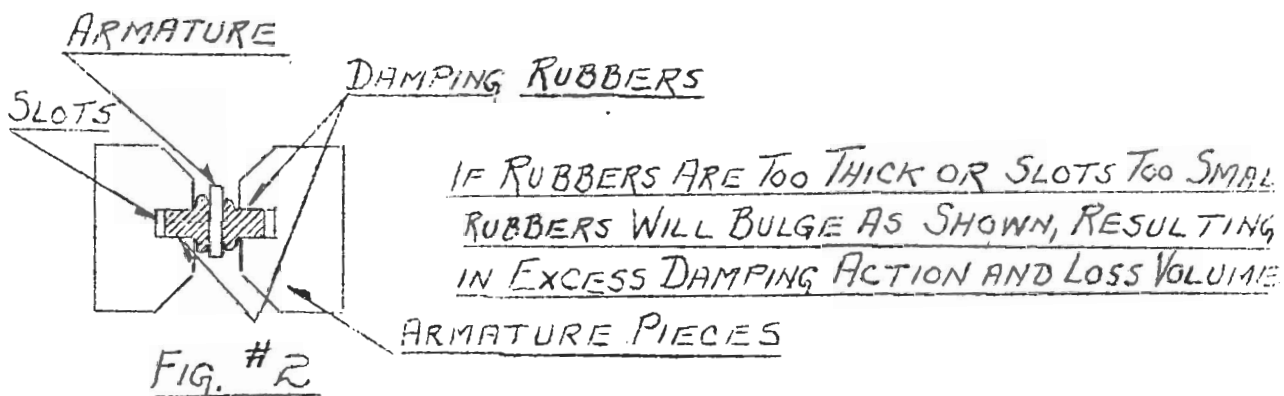
SKETCH TO ACCOMPANY BULLETIN # 8

SKETCH SHOWS CAUSE FOR LOSS OF VOLUME IN PICK-UP.

(a) Excessive damping, the pole piece slots may be too small or too narrow, resulting in improper damping action or prevention of proper damping adjustment by means of the adjustment provided for this purpose. That is, damping may be increased to an excessive amount but decreased damping will not result from change in adjustments provided, the narrowed slots in pole pieces preventing damping rubber from returning or resuming its natural position in slotted recess. To correct this condition in an emergency it is recommended that pole pieces be removed and the slots widened by filing. However, great care must be exercised in this operation, using a platinum file, trying the damping rubber frequently to insure a "snug" fit.

NOTE - TO CORRECT THIS CONDITION WIDEN SLOTS BY FILING SIDE WALLS, USING PLATINUM FILE OR EXTRA FINE FILE PERMITTING FREE MOVEMENT IN AND OUT OF DAMPING RUBBERS.

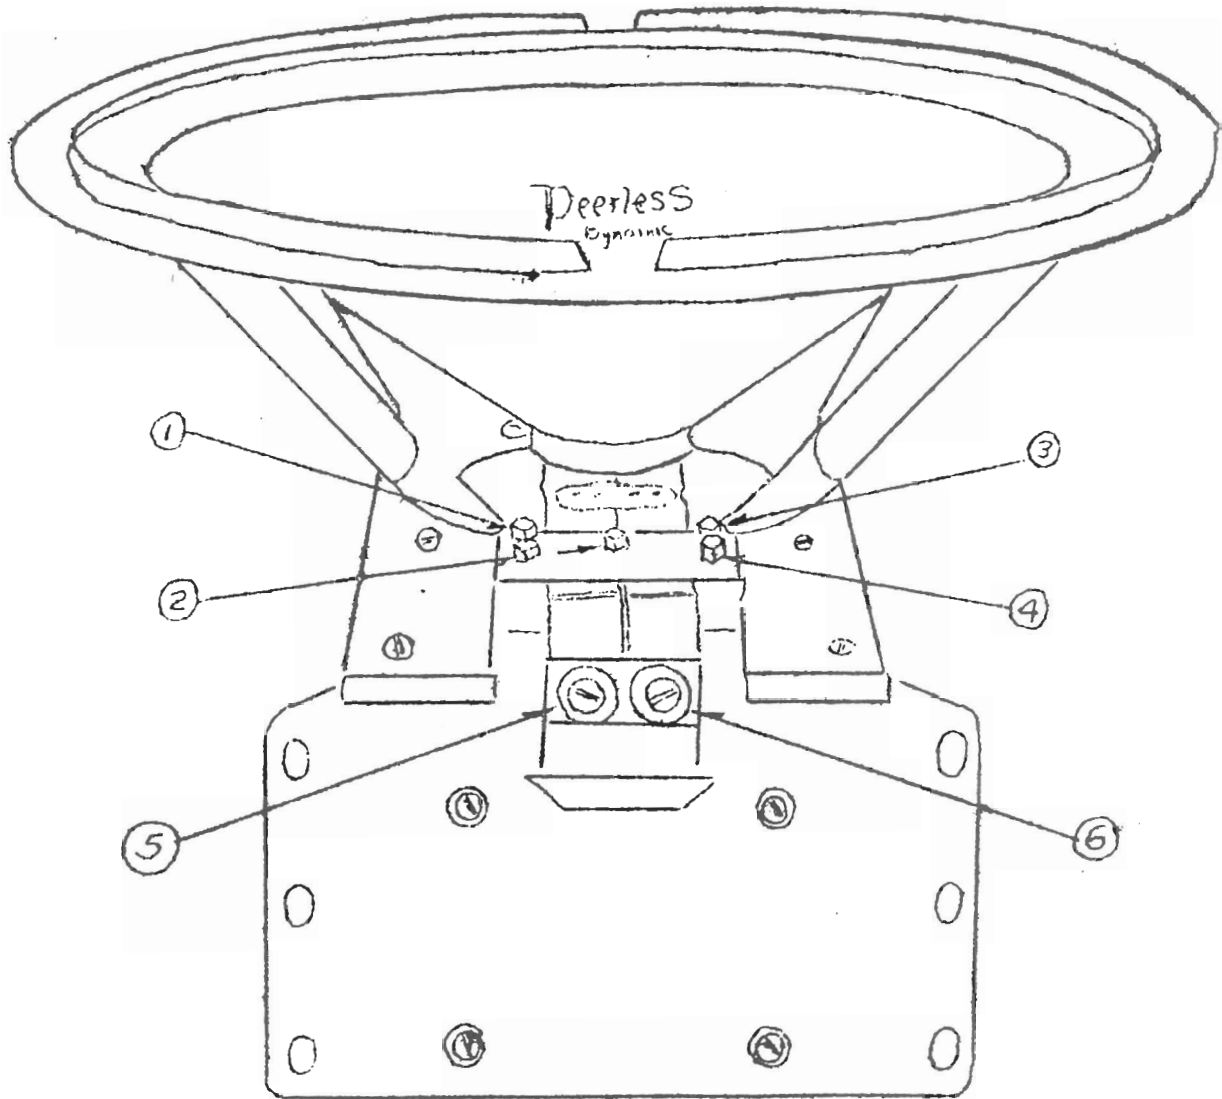
TO ACCOMPANY BULLETIN # 11.

One of our field Service Engineers has been consistantly reporting that he finds speaker bolts very loose. In order to get the best volume and reproduction the following bolts must be drawn up tight.

① VOICE COIL HOLDING BOLTS... ③

② " " " " ④

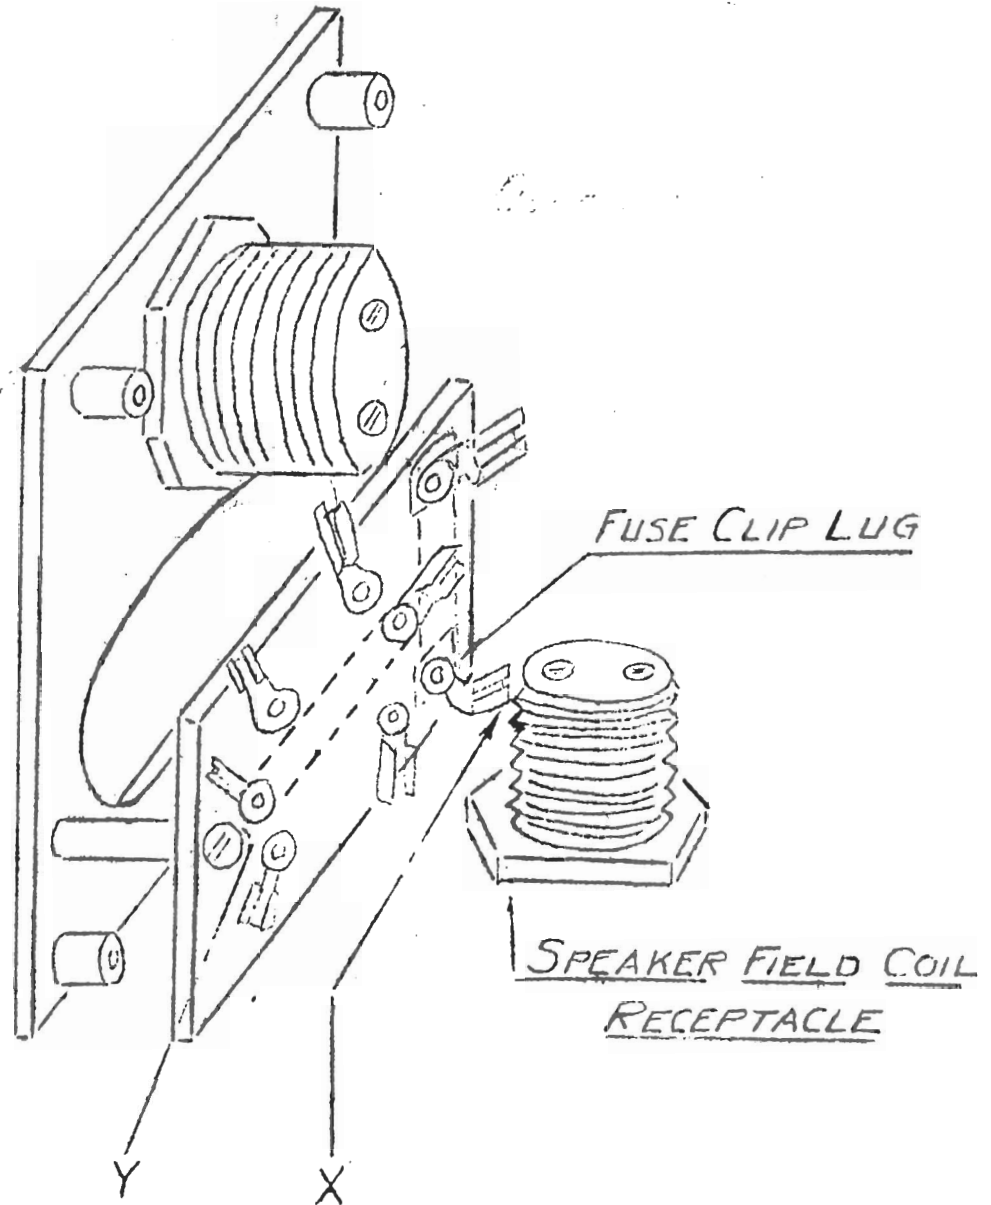
FIGURE 1.

1. A Western distributor reports a number of burned out antenna primary coils. Aside from Atmospheric discharges such as lightning we prescribe the following possible reasons which, under certain conditions, may contribute to the burning out of antenna coils.

2. The Attached figure indicates the location of possible short in chassis which will result in burned out primary IF THE GROUND WIRE IS ATTACHED TO ANTENNA POST OR IF ANTENNA ITSELF BECOMES GROUNDED.

4. If these grounds exist in chassis the chassis fuse will burn out repeatedly, as A.C. line plug is inserted in one position.

6. These grounds except in rare cases may be found only in some of the chassis bearing serial numbers below 3500.

5. By reversing the position of A.C. line plug, the fuse will not burn out--with the ground still present in chassis. However, for safety's sake we recommend removal of the ground.

7. If fuse trouble is experienced the "ground trouble" should be discovered and cured to avoid possibility of damage to antenna primary.
