RADIO
BULLETIN No. 48-147

November 5, 1948

TELEVISION SERVICE BULLETIN

SUBJECT: TELEVISION SERVICE SUGGESTIONS

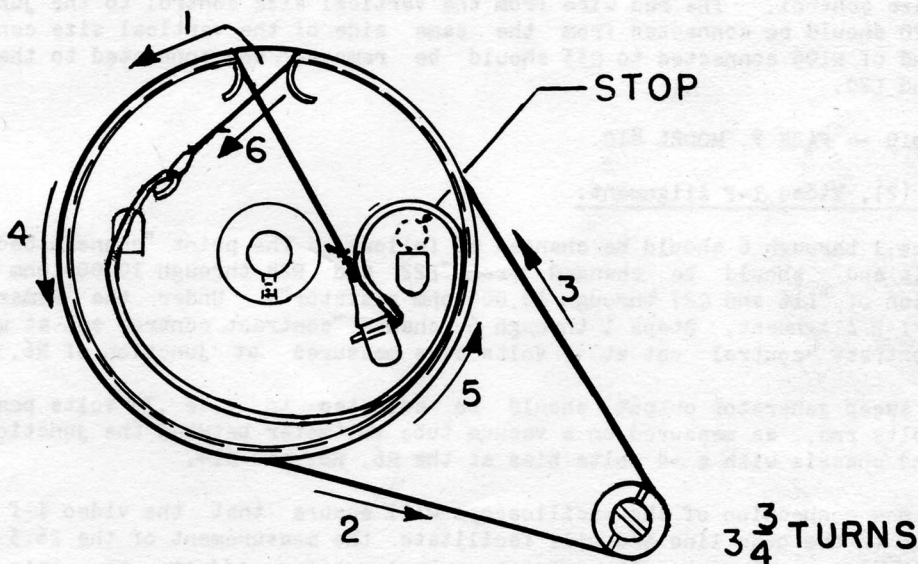
STRING TUNING DRIVE, MODEL 810.

The tuning control on the Model 810 has been changed from a rubber pulley friction drive to string drive. This was done to eliminate a small amount of backlash which resulted in complaints of critical tuning adjustment when operating on the high frequency channels.

When making this change-over, it is necessary to remove and discard the rubber tuning control pulley, the tuning drum, and the knurled tuning control concentric shaft.

The following new parts are necessary to make this change, and are assembled as shown in the figure:

1	Tuning Shaft	Cat. No. RMU-048	\$0.25
1	Pulley and Hub Assembly	Cat. No. RMW-045	.45
1	Cord Tension Spring	Cat. No. RMS-118	.10
	Dial Cord	Cat. No. RDC-032	\$2.50/25 yd.
